## A case study on Homestead Plinth Raise: An Effective Means of Adaptation to Climate Change

Md. Rabi Uzzaman, Program Officer, Community Climate Change Project (CCCP), Palli Karma-Sahayak Foundation

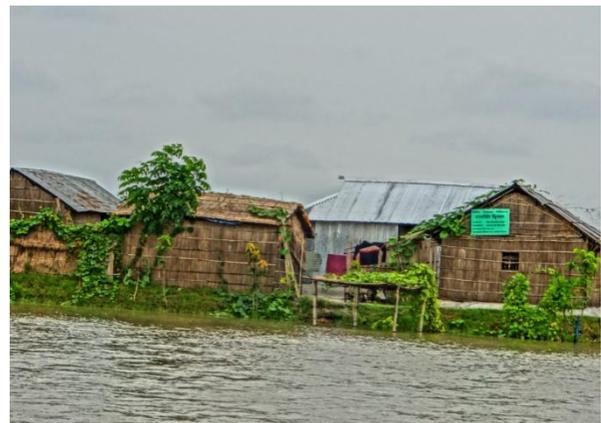
**Figure 3: Raised plinth stands high above flood water**

Ulipur upzaila in Kurigram district. Homesteads of 55 households in 11 clusters were raised above flood level. It was observed that each of the clusters was 2-2.5 ft above flood level.

This year, their homesteads are raised under CCCP. They are very happy and feel comfortable now. Their homesteads have not been submerged by flood water. They are living as usual with their family members with all the household resources. It was informed during field visit that 2.5 to 3 ft depth flood water stagnation observed for around 13 days. During that period, they continued their household works as usual and living on dry places. They could cook food two times a day as they used to do it in normal situation. Furthermore, another flood affected 8 households having 28 members with their household resources took shelter on this cluster. Among them, children and women are majority (12 children, 9 women and 7 men). There are 7 cows in the cluster during normal time but during that flood 27 cows

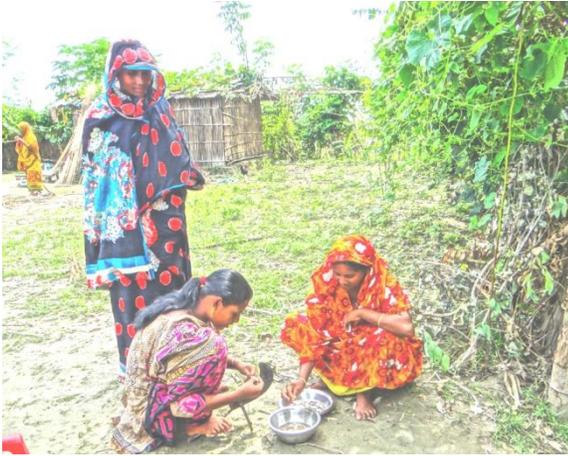
Figure 4: Leading normal life at the time of flood

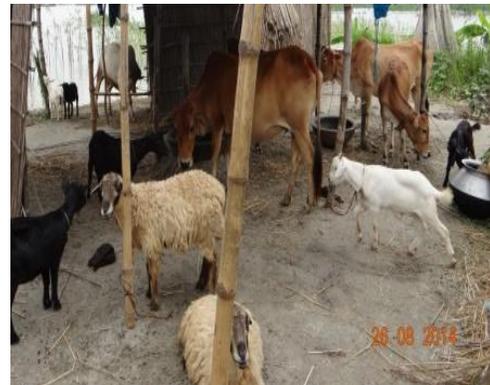
Figure 5: Livestock of surrounding areas take shelter on raised plinth

took shelter. This means sheltered cows are about four times than that of normal time. Similarly, the five households have 14 goats and sheep but during flood, we found 25 more. The following table shows a comparative scenario during normal situation and the situation of flood:

Description	During normal situation	Took shelter during flood	Total number during flood
Human	22	28	50
Cows	7	27	34
Goat and sheep	14	25	39

The above information confirms that more than double of the cluster people with their livestock and household resources took shelter on the raised cluster. But the people raised some problems such as lack of safe drinking water, lack of sanitary latrines and poor road and water communication system. The first two problems are planned in sub-projects under CCCP. But in the case of communication, there is the only way communication through boat and vessel made by banana tree.
